National Aeronautics and Space Administration

NASA-DoD Lead-Free Electronics Project

DRAFT Joint Test Report

July 2011

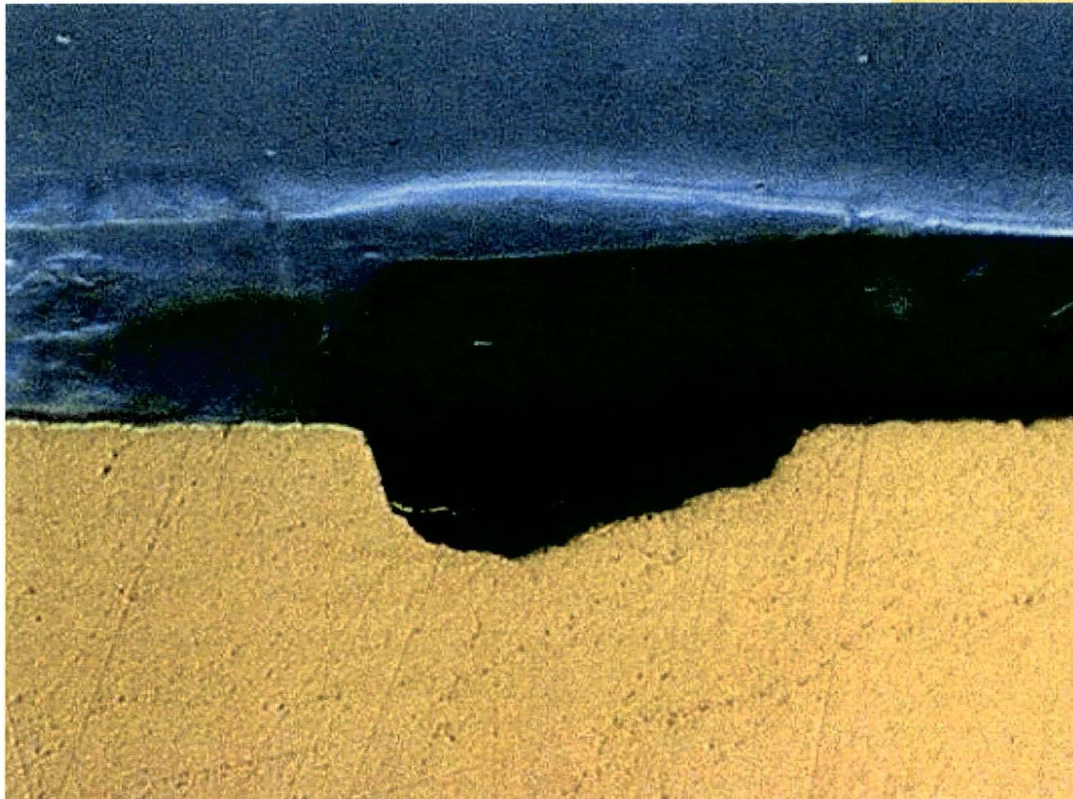
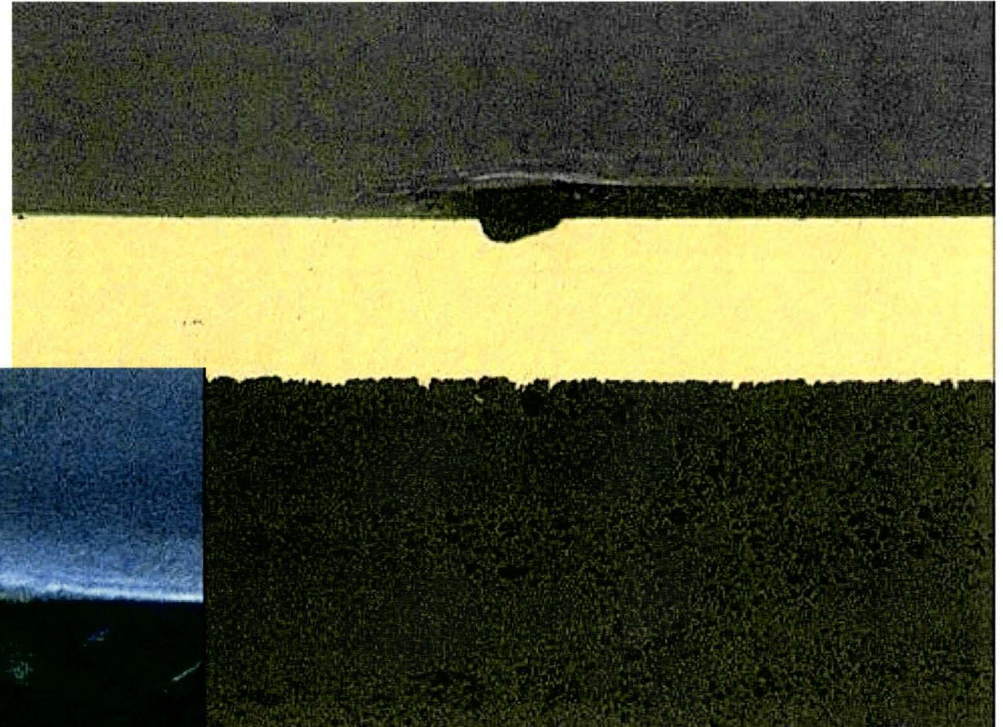
Test Vehicle Fabrication Issue #2

CSP
Daisy
Chain
Routing
Issue

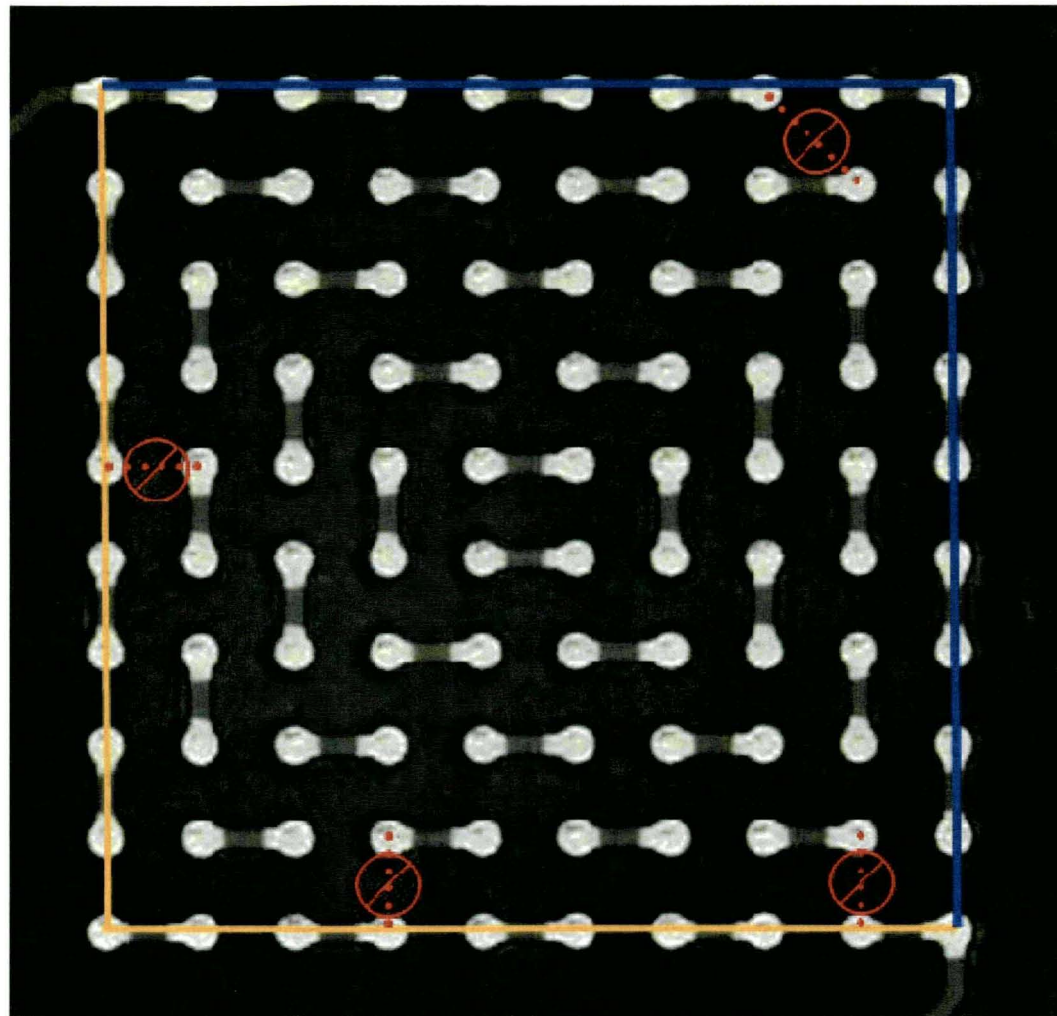
Test Vehicle Fabrication Issue #3

QFN
Trace
Routing
Issue

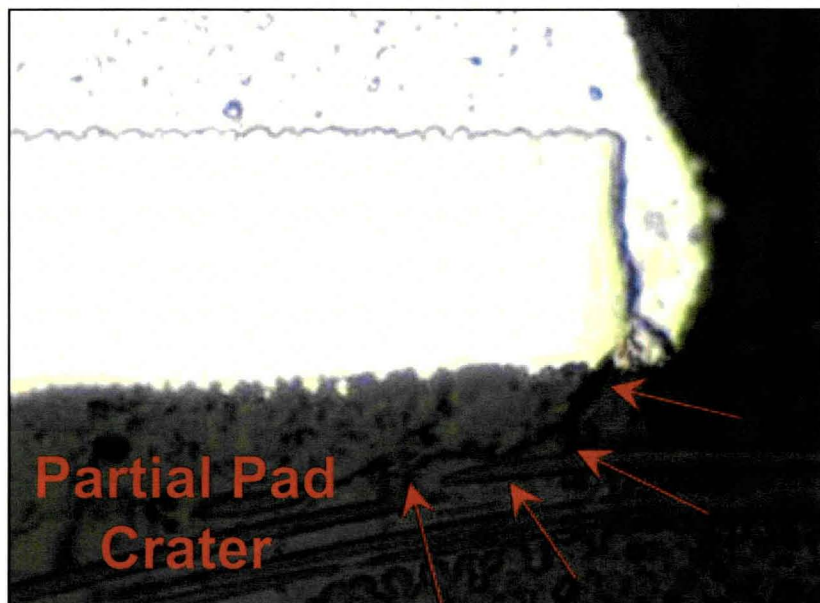
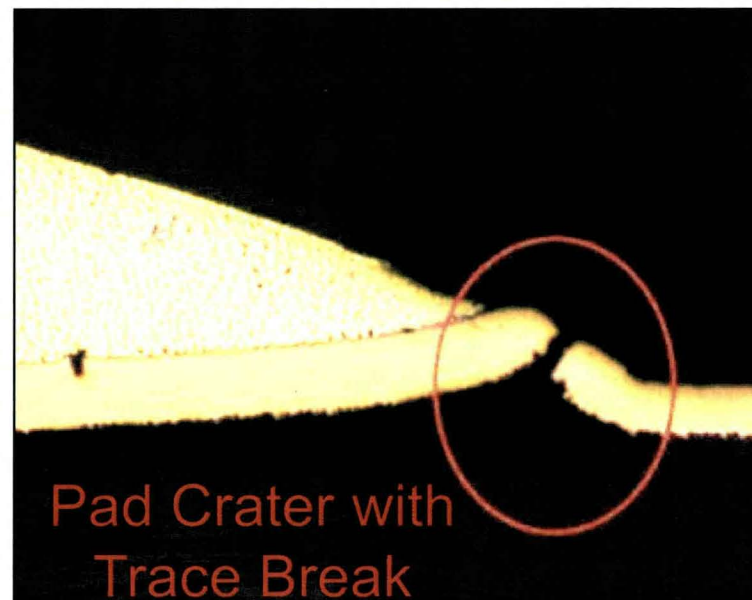
Drop Testing

- Drop test reliability was **component type dependent**.
- The only component type to show a significant number of electrical failures during this test were the **BGAs**. The BGA-225 electrical failures mostly occurred at or near the corner joints.
- The predominant damage mechanism in drop testing is **pad cratering**. Cracks propagate through the board material between the laminate and glass fiber under the pads.

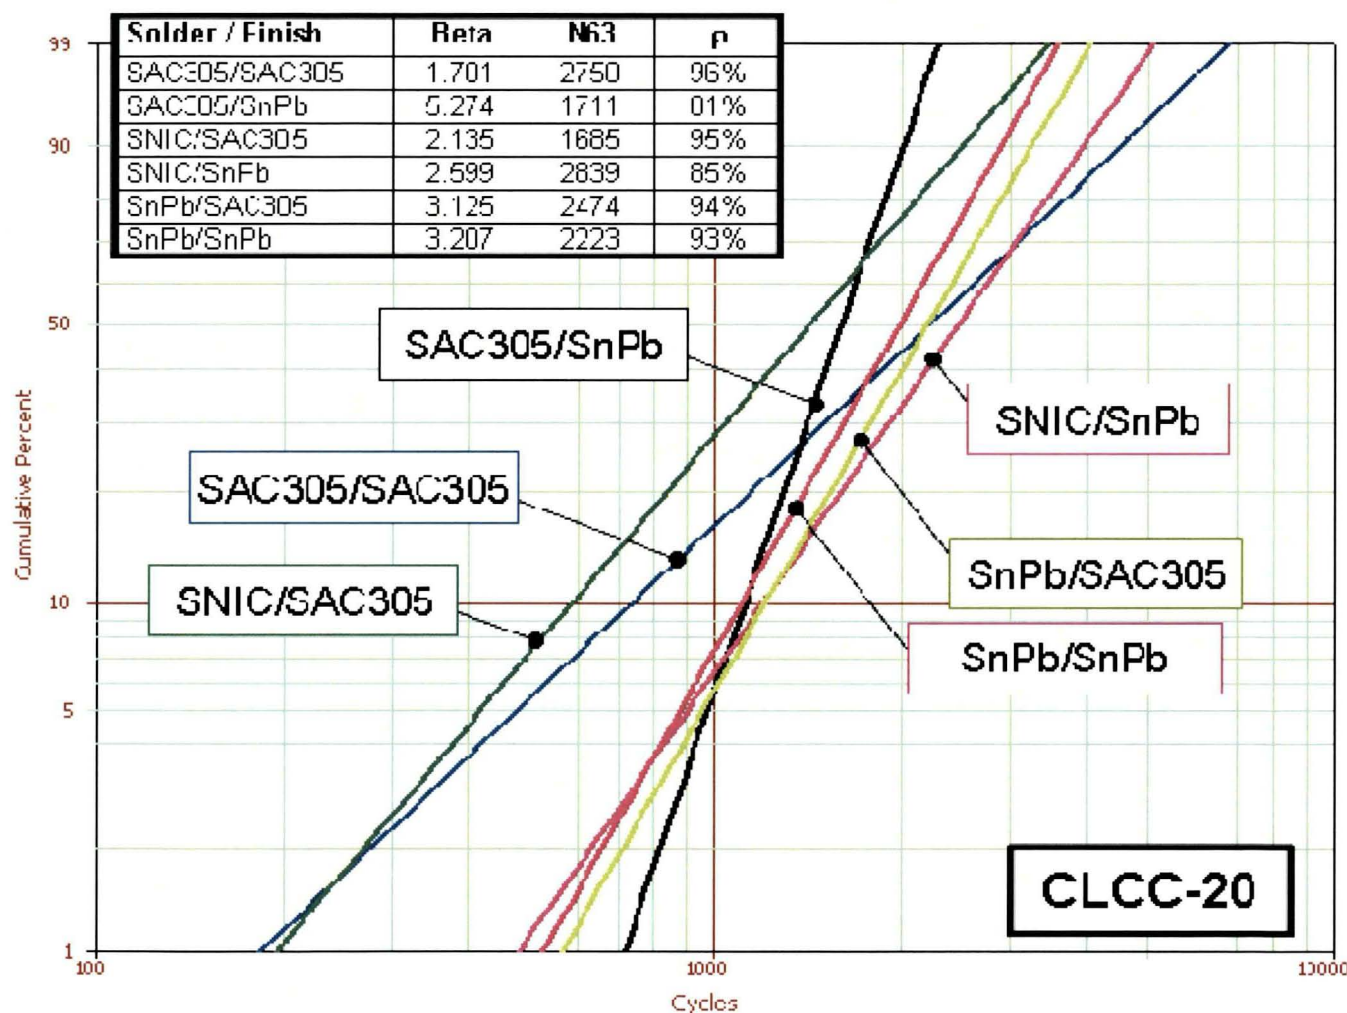
CLCC Results:

SnPb
Outperformed
Lead-free
Alloys As
Expected for
High Stress
Situation
(Reference
JCAA-JGPP
Phase I Data)

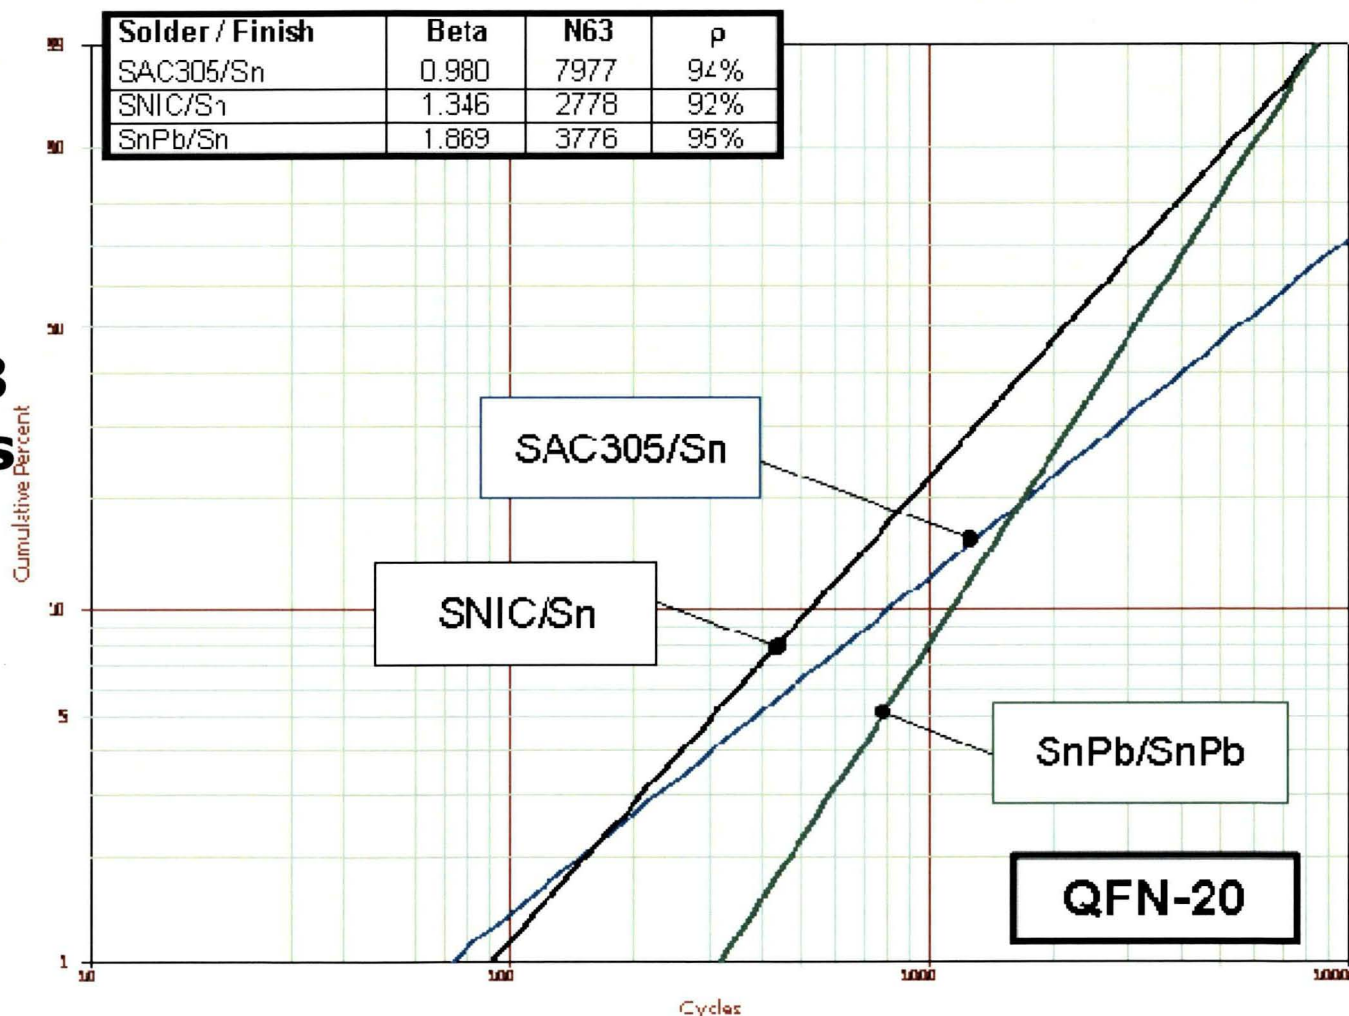
QFN Results:

**SnPb
Outperformed
Lead-free
Alloys but N63
Weibull Values
are very good
(aka "how
good is good
enough?"**

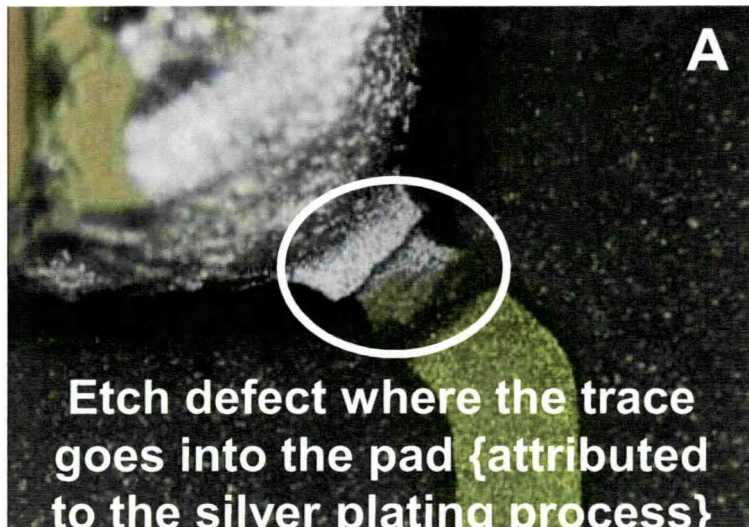
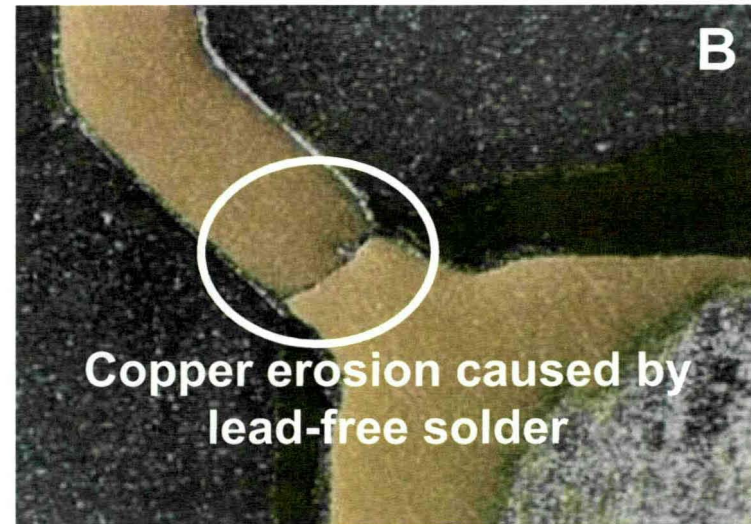
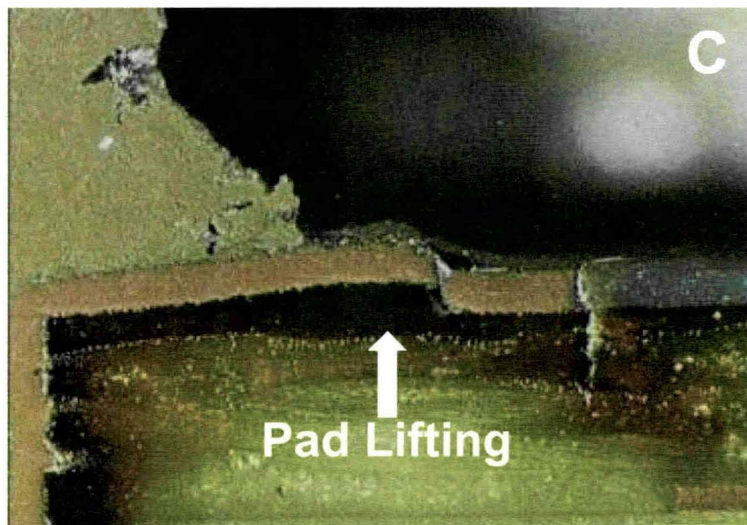
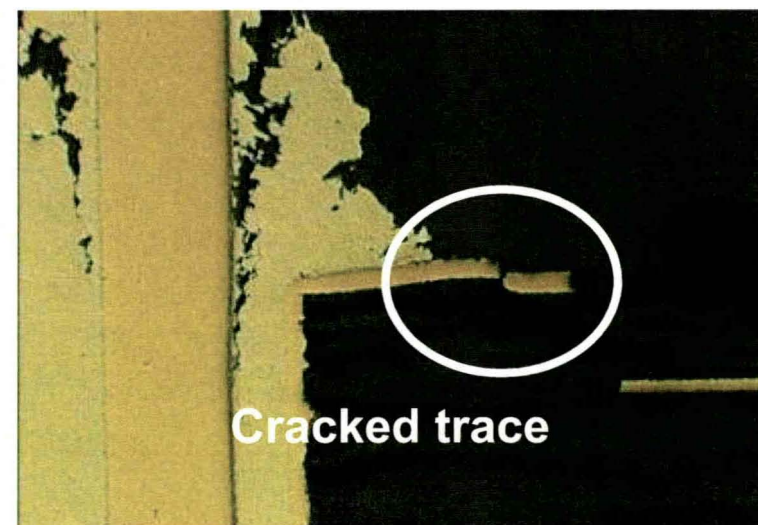
Three sufficient conditions resulting in unexpectedly high PDIP failures (cracked traces) on *lead-free* assemblies:
A+B+C = Failure

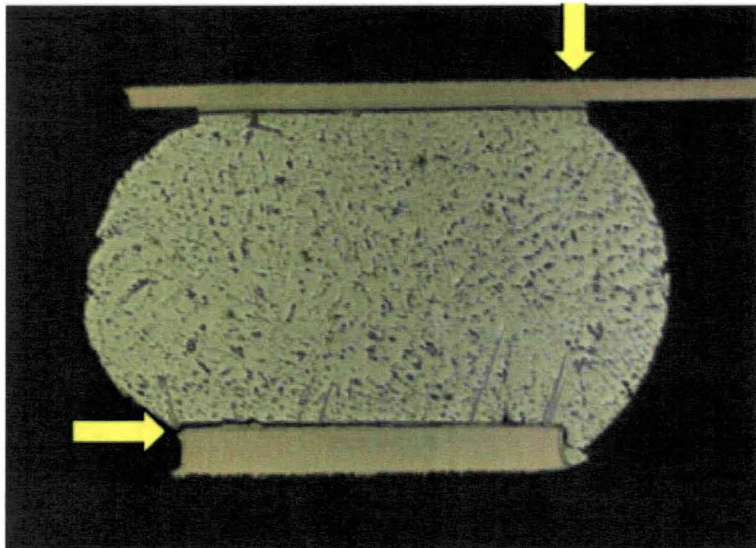
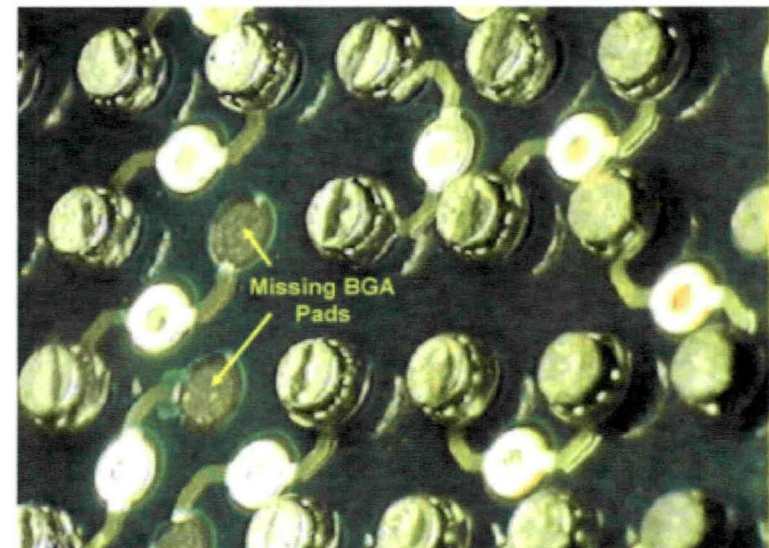
Vibration Testing

- The results of this study suggest that for many component types, the **lead-free solders tested are not as reliable as eutectic SnPb solder** with respect to vibration. **Rework** also had a **negative** effect on both SnPb and lead-free solders with respect to vibration.
- For severe vibration environments, the use of lead-free solders may require the use of stiffeners, bumpers, or vibration isolators to reduce PWA flexure and reduce solder joint strains to acceptable levels.
